O-RING FAILURE ANALYSIS

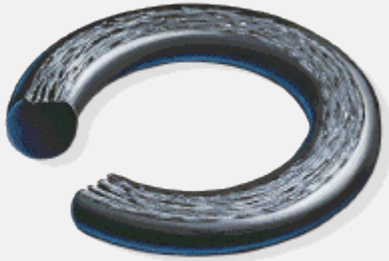
COMMON SEAL FAILURES : ABRASION

Description: The seal or parts of the seal exhibit a flat surface parallel to the direction or motion. Loose particles and scrapes may be found on the seal surface.

Contributing Factors: Rough sealing surfaces. Excessive temperature. Process environment containing abrasive particles. Dynamic motion. Poor elastomer surface finish.

Suggested Solutions: Use recommended gland surface finishes. Consider internally lubed elastomers. Eliminate abrasive components.

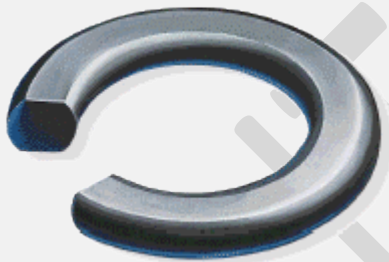
COMPRESSION SET

Description: The seal exhibits a flat-sided cross-section, the flat sides corresponding to the mating seal surfaces.

Contributing Factors: Excessive compression. Excessive temperature. Incompletely cured elastomer. Elastomer with high compression set. Excessive volume swell in chemical.

Suggested Solutions: Low compression set elastomer. Proper gland design for the specific elastomer. Confirm material compatibility.

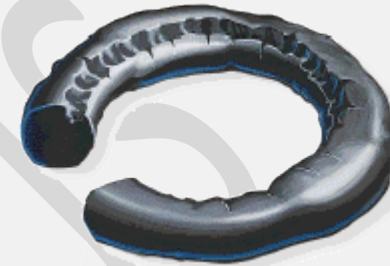
CHEMICAL DEGRADATION

Description: The seal may exhibit many signs of degradation including blisters, cracks, voids or discoloration. In some cases, the degradation is observable only by measurement of physical properties.

Contributing Factors: Contributing Factors: Incompatibility with the chemical and/or thermal environment.

Suggested Solutions: Selection of more chemically resistant elastomer.

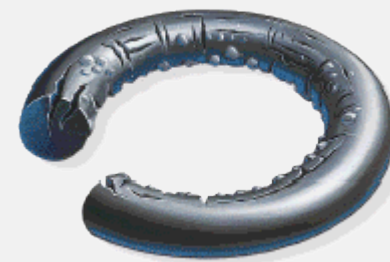
EXPLOSIVE DECOMPRESSION

Description: The seal exhibits blisters, pits or pocks on its surface. Absorption of gas at high pressure and the subsequent rapid decrease in pressure. The absorbed gas blisters and ruptures the elastomer surface as the pressure is rapidly removed.

Contributing Factors: Rapid pressure changes. Low-modulus/hardness elastomer.

Suggested Solutions: Higher-modulus/hardness elastomer. Slower decompression (release of pressure).

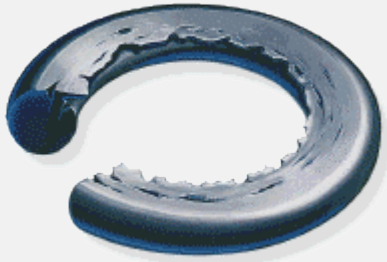
EXTRUSION

Description: The seal develops ragged edges (generally on the low-pressure side) which appear tattered.

Contributing Factors: Excessive clearances. Excessive pressure. Low-modulus/hardness elastomer. Excessive gland fill. Irregular clearance gaps. Sharp gland edges. Improper sizing.

Suggested Solutions: Decrease clearances. Higher-modulus/hardness elastomer. Proper gland design. Use of polymer backup rings.

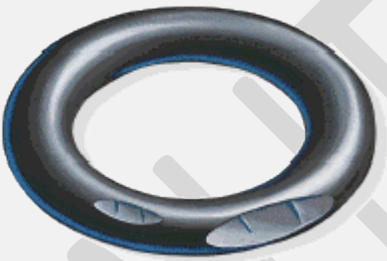
INSTALLATION DAMAGE

Description: The seal or parts of the seal may exhibit small cuts, nicks or gashes.

Contributing Factors: Sharp edges on glands or components. Improper sizing of elastomer. Low-modulus/hardness elastomer. Elastomer surface contamination.

Suggested Solutions: Remove all sharp edges. Proper gland design. Proper elastomer sizing. Higher-modulus/hardness elastomer.

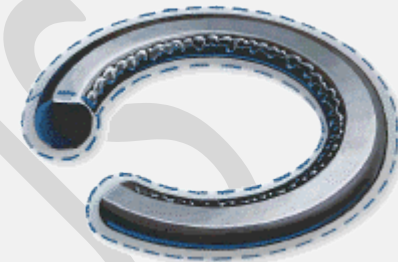
OUTGASSING / EXTRACTION

Description: This failure is often very difficult to detect from examination of the seal. The seal may exhibit a decrease in cross-sectional size.

Contributing Factors: Improper or improperly cured elastomer. High vacuum levels. Low hardness/plasticized elastomer.

Suggested Solutions: Avoid plasticized elastomers. Ensure all seals are properly post-cured to minimize outgassing.

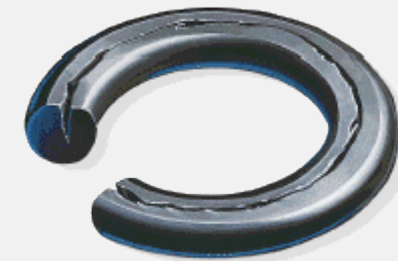
OVERCOMPRESSION

Description: The seal exhibits parallel flat surfaces (corresponding to the contact areas) and may develop circumferential splits within the flattened surfaces.

Contributing Factors: Improper design—failure to account for thermal or chemical volume changes, or excessive compression.

Suggested Solutions: Gland design should take into account material responses to chemical and thermal environments.

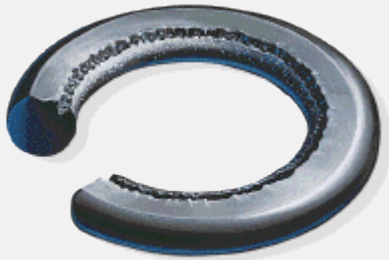
PLASMA DEGRADATION

Description: The seal often exhibits discoloration, as well as powdered residue on the surface and possible erosion of elastomer in the exposed areas.

Contributing Factors: Chemical reactivity of the plasma. Ion bombardment (sputtering). Electron bombardment (heating). Improper gland design. Incompatible seal material.

Suggested Solutions: Plasma-compatible elastomer and compound. Minimize exposed area. Examine gland design.

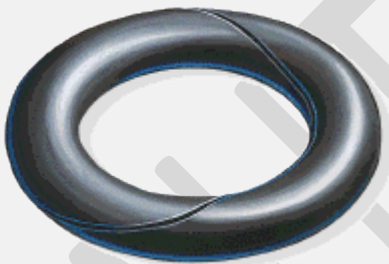
SPIRAL FAILURE

Description: The seal exhibits cuts or marks which spiral around its circumference.

Contributing Factors: Difficult or tight installation (static). Slow reciprocating speed. Low-modulus/hardness elastomer. Irregular O-ring surface finish (including excessive parting line). Excessive gland width. Irregular or rough gland surface finish. Inadequate lubrication.

Suggested Solutions: Correct installation procedures. Higher-modulus elastomer. Internally-lubed elastomers. Proper gland design. Gland surface finish of 8–16 microinch RMS. Possible use of polymer backup rings.

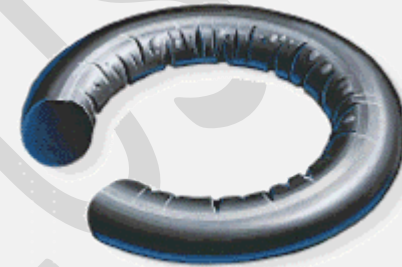
THERMAL DEGRADATION

Description: The seal may exhibit radial cracks located on the highest temperature surfaces. In addition, certain elastomers may exhibit signs of softening—a shiny surface as a result of excessive temperatures.

Contributing Factors: Elastomer thermal properties. Excessive temperature excursions or cycling.

Suggested Solutions: Selection of an elastomer with improved thermal stability. Evaluation of the possibility of cooling sealing surfaces.
